# **Terrigal and Coastal Lagoon Audit: Terrigal Catchment Audit**

Water quality investigation report 2

*January 2020*

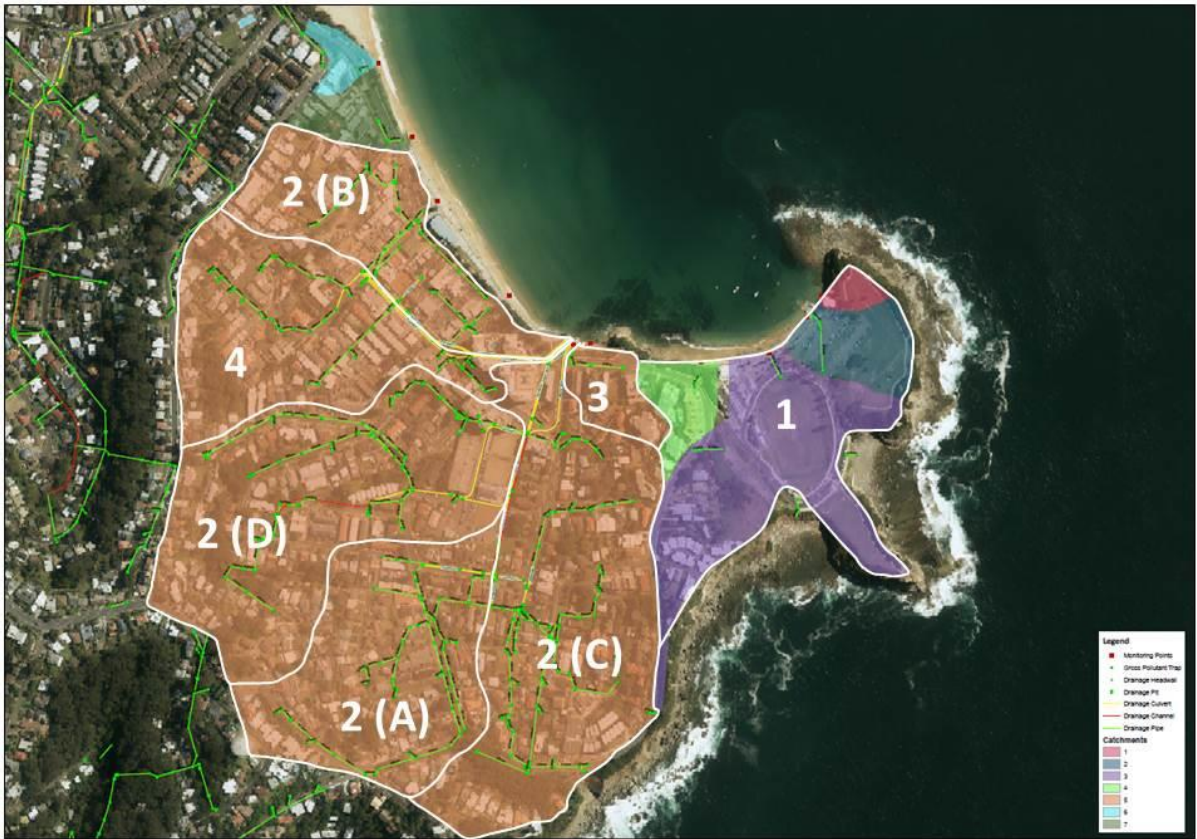
Figure 3: Priority sub-catchment zones scheduled for works in the 2018-2019 and 2019-2020 financial years based on stormwater quality. Phase 2 of the audit will reassess the priority sub-catchment map based on microbial load.

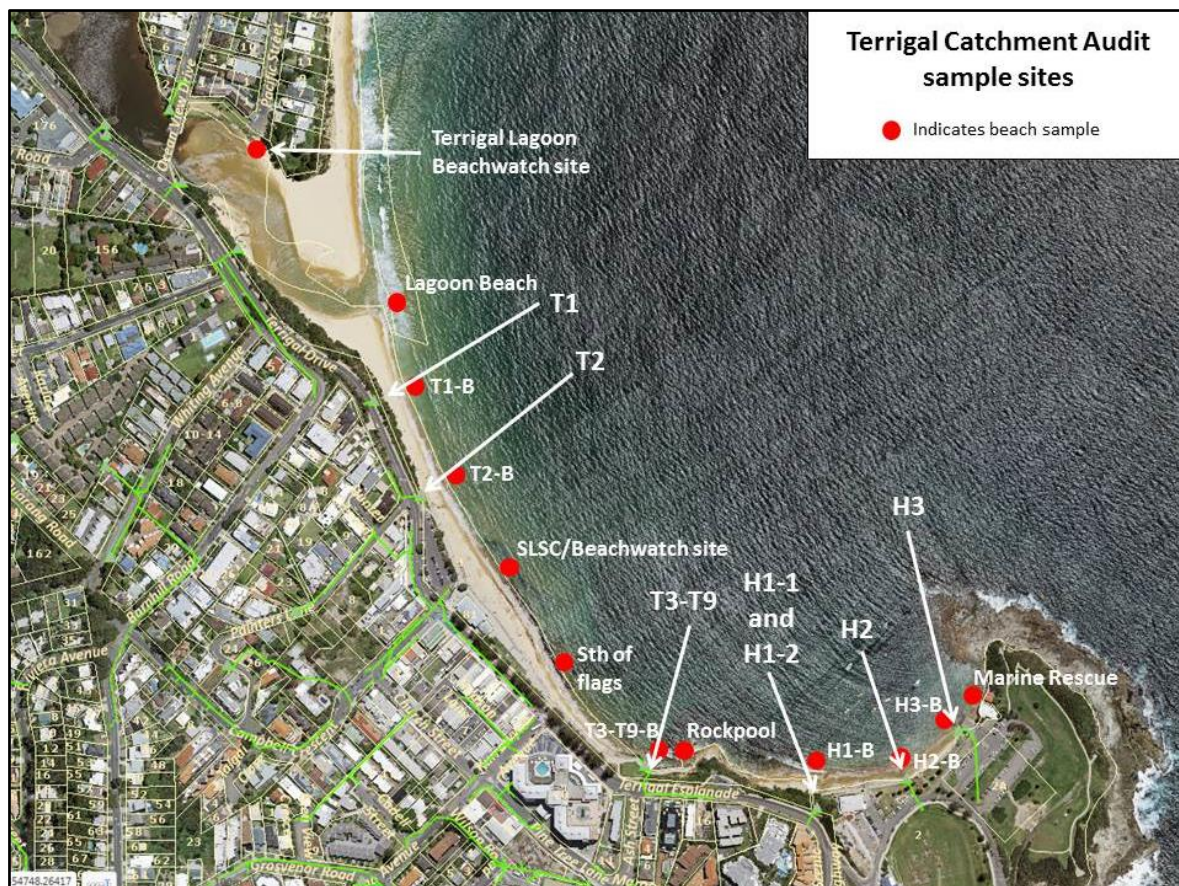
Figure 6: Sample sites for the Terrigal Catchment Audit.

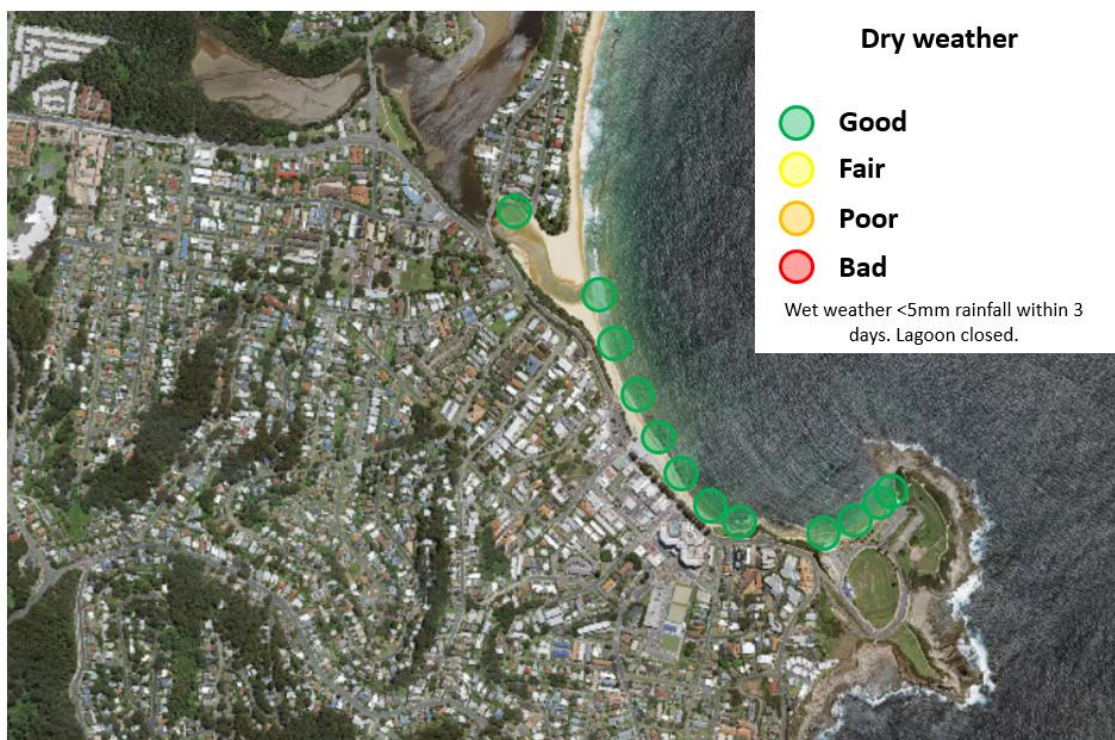
The low average levels of Enterococci bacteria at all locations indicate that during dry weather, any contamination is quickly diluted and does not affect the swim safety of the beach. Further testing has been undertaken in the offshore zone where swimmers cross to Terrigal Haven. These tests are investigating if the embayment is being affected by minor levels seen at T3-9B and will be included in subsequent reports.

A single outlier from Sth of Flags on 20 May 2019 and Marine Rescue on 9 May 2019 were excluded from the map below. These anomalies were not consistent with results from surrounding locations collected on the same days and were not explained by the existing conditions. The outliers were included in swim safety percentage calculations above.

\*These values are derived from 56 samples 17 January to 31 October 2019. The audit is an ongoing investigation and values will change as the audit progresses.

Figure 7: Average water quality 55 sampling days 17 January – 31 October 2019 (average excludes a single outlier at Sth of Flags and Marine Rescue which is discussed in the text).

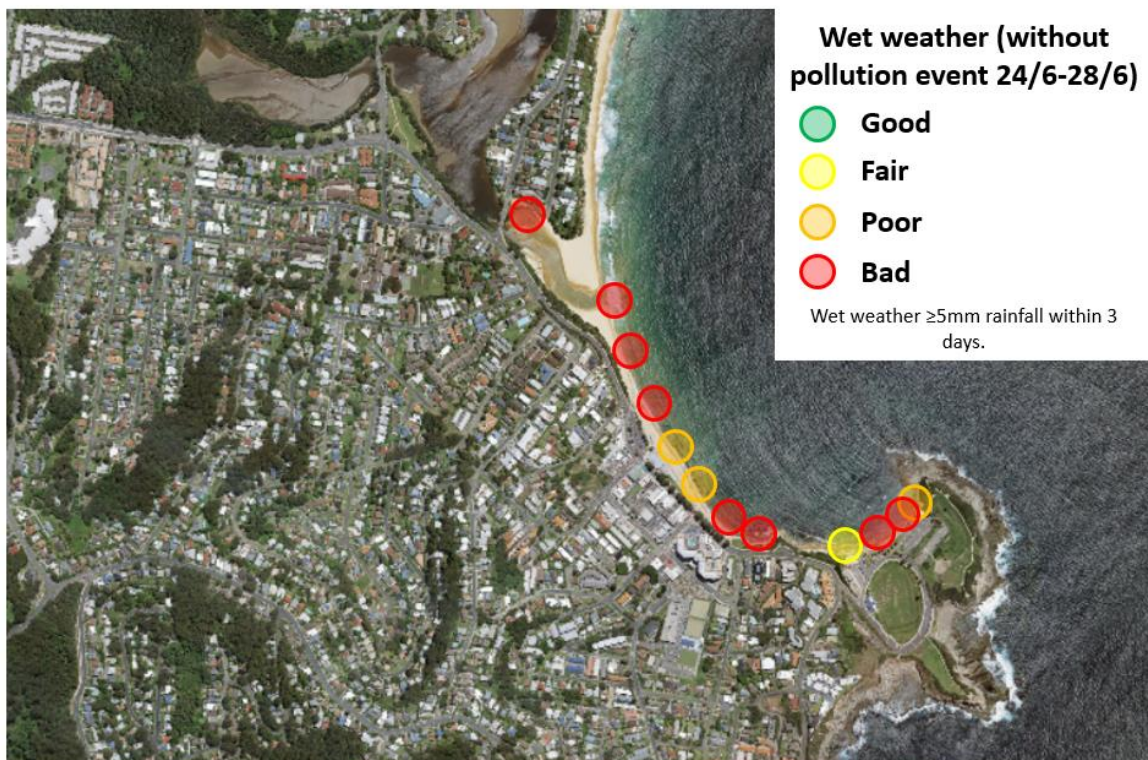
During rainfall, elevated levels of Enterococci bacteria occurred at multiple locations between Terrigal Lagoon and Terrigal Haven. On Terrigal Beach directly outside the T3-T9 drains, 20% of the ocean samples were considered "Good" in wet weather, Sth of Flags was considered "Good" to swim 55% of the time and the Rockpool was considered "Good" to swim 54% of the time\*.

Figure 8: Average water quality of wet weather sampling days from 17 January – 31 October 2019, excluding the pollution event from 24 June- 28 June 2019.

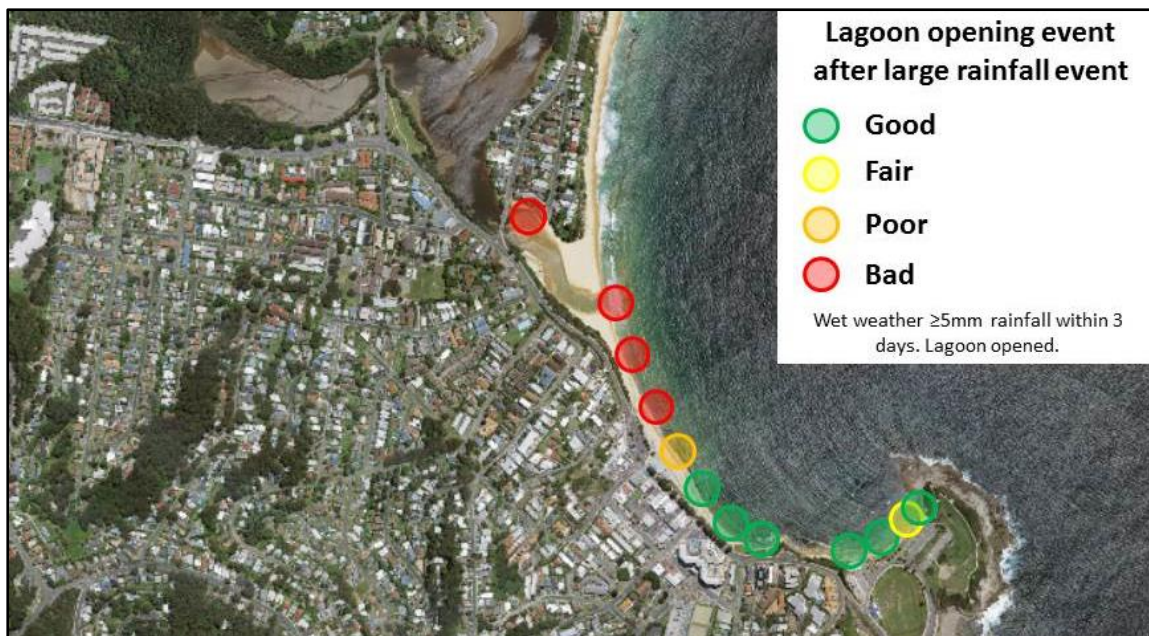
The entrance to Terrigal Lagoon opens to the ocean on occasions through natural and manual (mechanical) processes. During the lagoon opening on 2 April 2019, the Terrigal Catchment Audit took samples before (1 April 2019) and after (3 April 2019) the lagoon was manually opened. A rainfall total of 44.5mm was recorded over three days period prior to lagoon opening. Ocean conditions resulted in the lagoon water moving south, in front of the SLSC and evidence of turbid water was seen at the sample site known as Sth of Flags. Enterococci sampling indicated that beach sites were not suitable for swimming.

In the week or so following the lagoon opening and rainfall event, water samples from 9 April 2019 showed the beach was "Good" for swimming at 100% of Terrigal Beach and 75% of Terrigal Haven (Table 1 shows definitions for "Good", "Fair", "Poor" and "Bad").

Figure 9: Water quality (single day sample 3/4/2019).

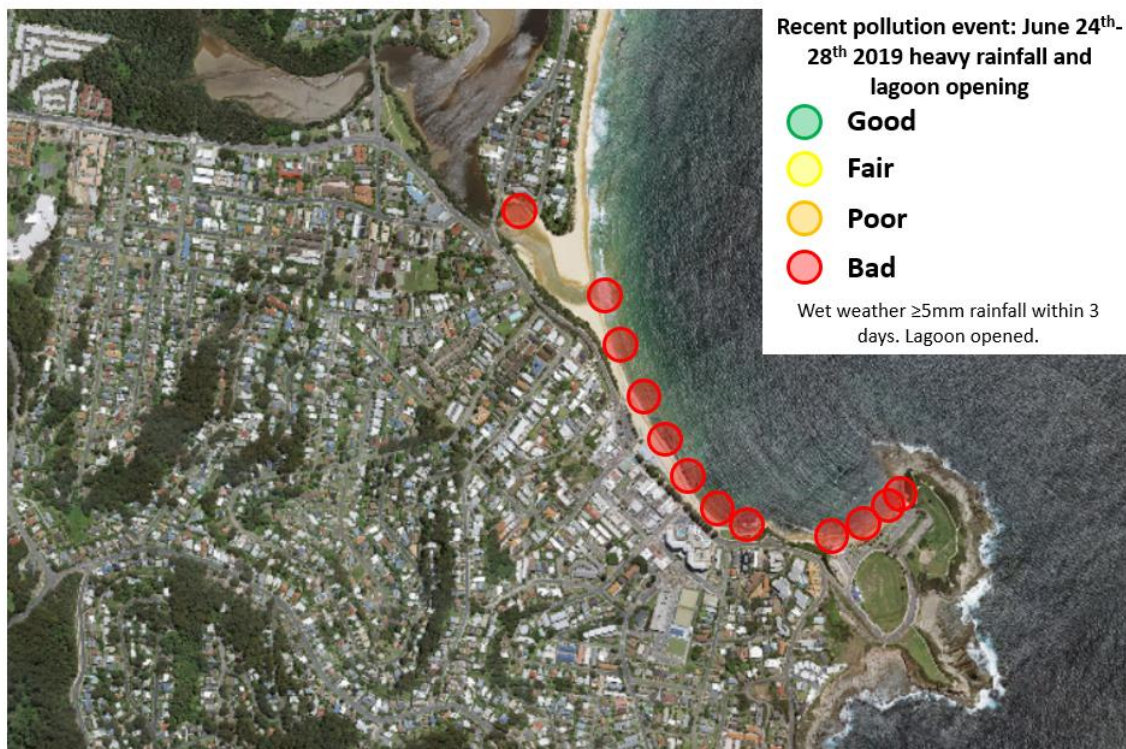
Analysis of results show the lagoon opening caused minimal impact on the beach water quality initially, indicated by the low levels of bacteria at the Lagoon Beach, T1-B and T2-B sites on the first sample day (24 June 2019). This indicates that the lagoon water plume had not yet reached the SLSC or the south of the beach.

Results after the initial rainfall event from 25 to 28 June show a decrease in Enterococci over time for all ocean sites and stormwater pipes, with a return to safe swimming conditions at all ocean locations by the 28 June 2019. Terrigal Beach, Terrigal Haven were not opened until 1 July as the testing takes 24-48 hours to complete.

Figure 10: Water quality after large rainfall event and lagoon opening (Enterococci sampling from 24 June - 28 June 2019).

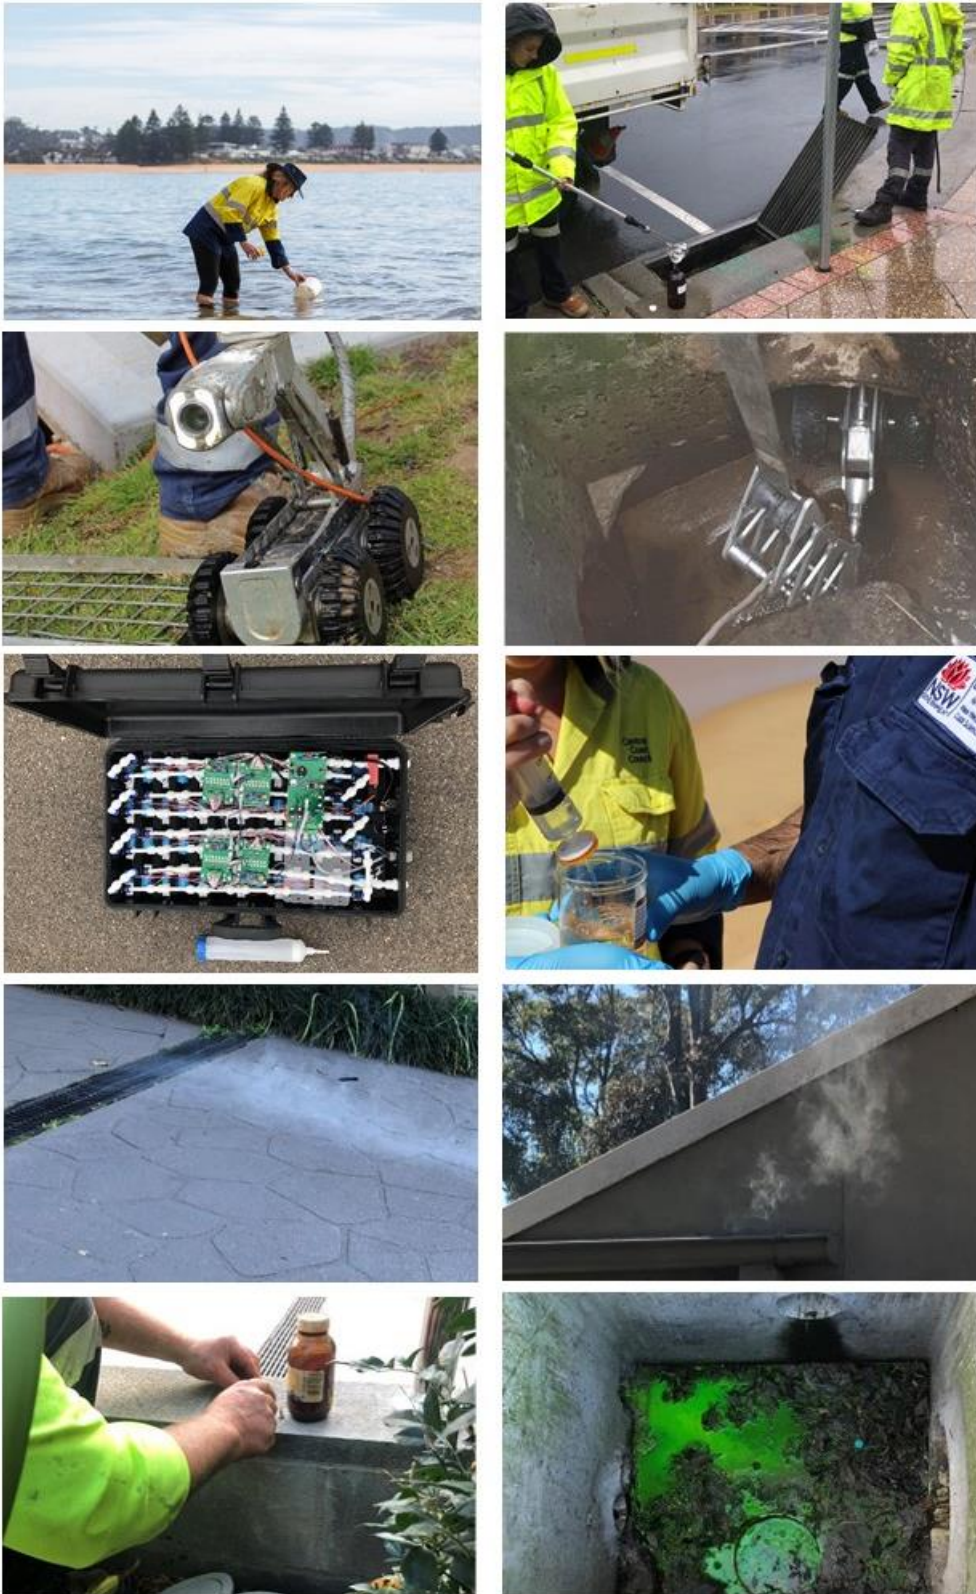
Photo line: 1 Water sampling in ocean and catchment, 2 CCTV camera and camera going down a pipe, 3 flow sampler and filtering for sediment sampling, 4 smoke testing showing smoke from driveway drainage and gutters, line 5 dye testing in a pipe.

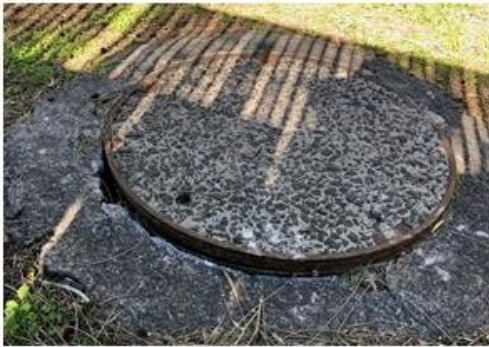
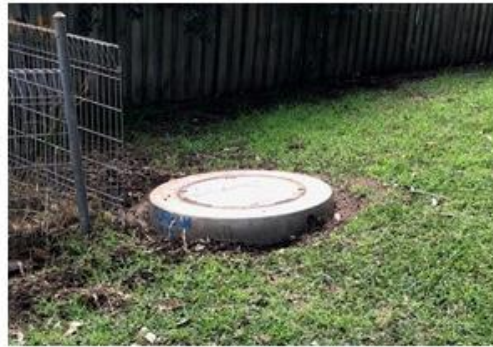
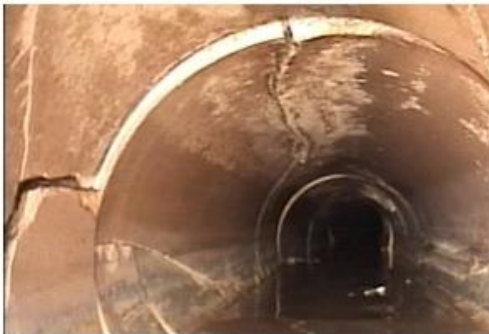
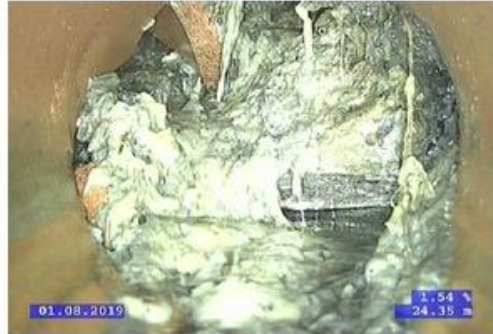
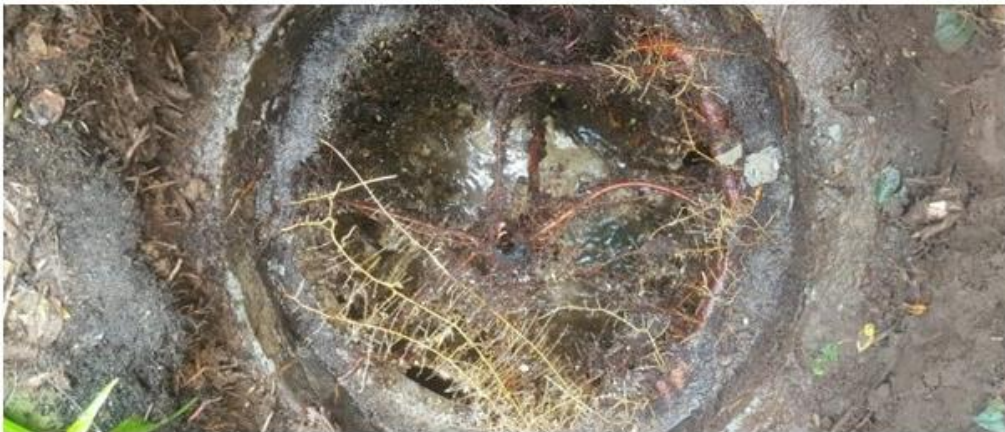
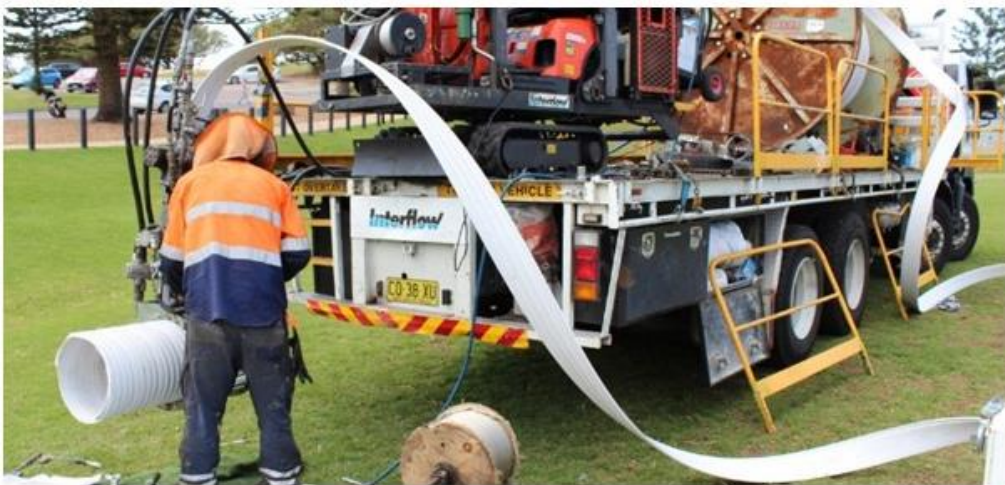
General sewer CCTV inspections throughout the Terrigal catchment have detected structural issues in a number of sewer pipes. Sewer network structural issues can vary in severity from minor fractures and displacements which may not cause exfiltration, to cracks, displacements and collapses which likely or directly show evidence of exfiltration. Third party damage to Council's sewer infrastructure that is not reported to Council, may also cause exfiltration of sewage to the stormwater network.

Photo line: 1 broken man hole and repaired and raised manhole from the reveal and seal program, 2 cracked and collapsed sewer pipes which have been fixed, 3 root intrusion, 4 pipe relining.

Current investigations are focussed on vitreous clay pipe and asbestos cement pipe. These pipe types are known for deterioration with displaced joints and cracking type failures. Lower risk infrastructure may also need assessment as a part of the audit, as well as private infrastructure and this work will be scheduled after high risk infrastructure has been thoroughly assessed and as required.

Where structural or other issues are identified, they will be scheduled for remediation based on the risk category. This applies to both public and private assets. Council will work with landholders to rectify any issues identified on private land through existing compliance processes. In the interest of privacy, these will not be reported by location however a total number of private repairs will be included. If water quality remains a concern beyond these initial repairs, future investigations may expand into private land and lower risk infrastructure.
