Doyalson Wyee RSL Club Limited
Care of
Urbis Pty Ltd

Asbestos in Soils Assessment

49-65 Wentworth Avenue and
80, 90, 100 and 110 Pacific Highway
Doyalson NSW

1 November 2019

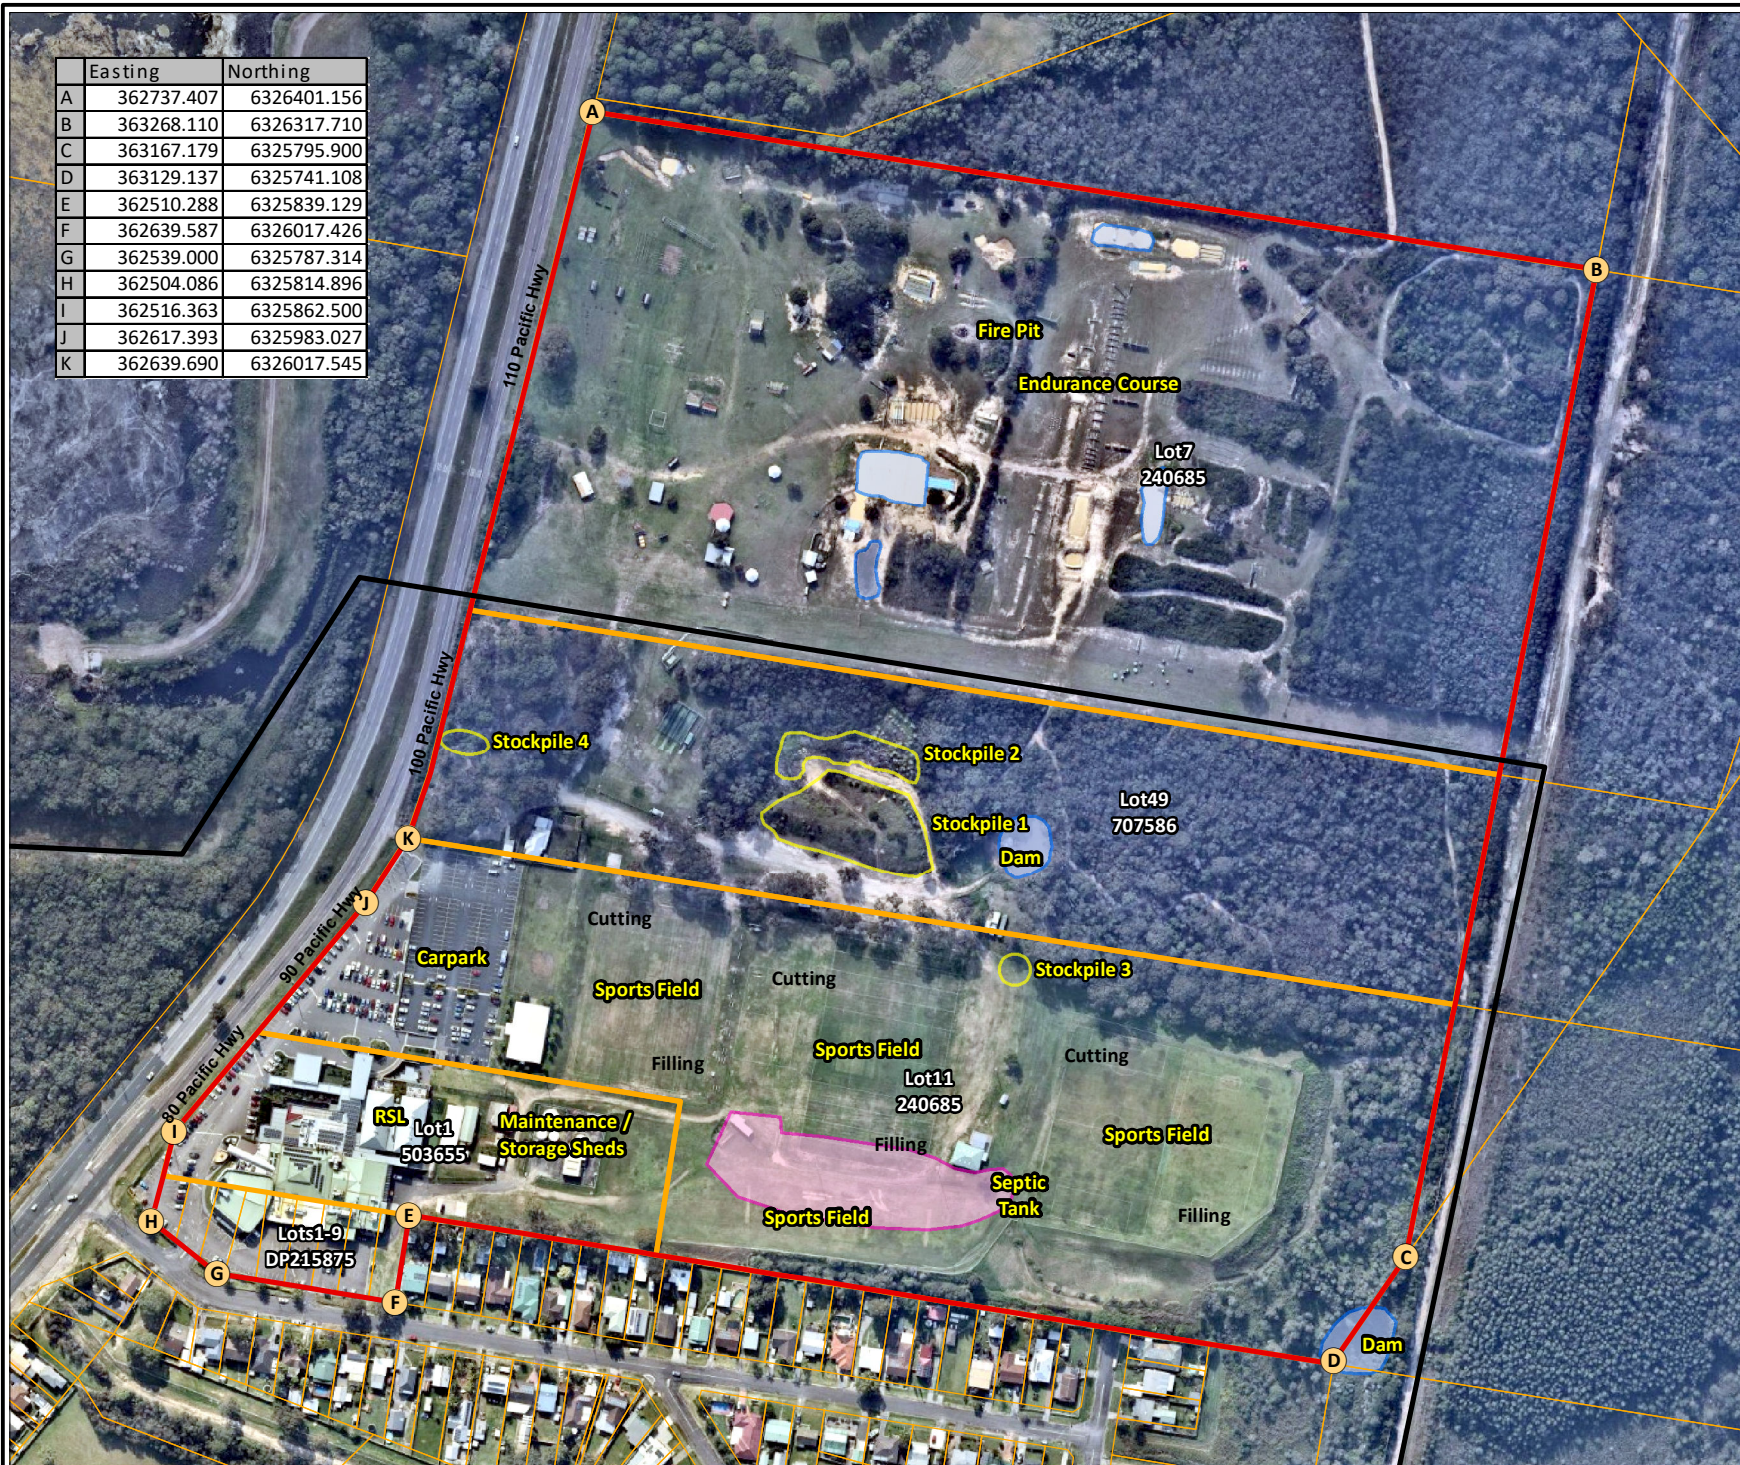
FIGURE 2

The southwest portion of the area was occupied by evaporation trenches associated with sports field operations. Portions of the southwestern site area were noted to be sodden.

**SITE LAYOUT AND
FEATURES**

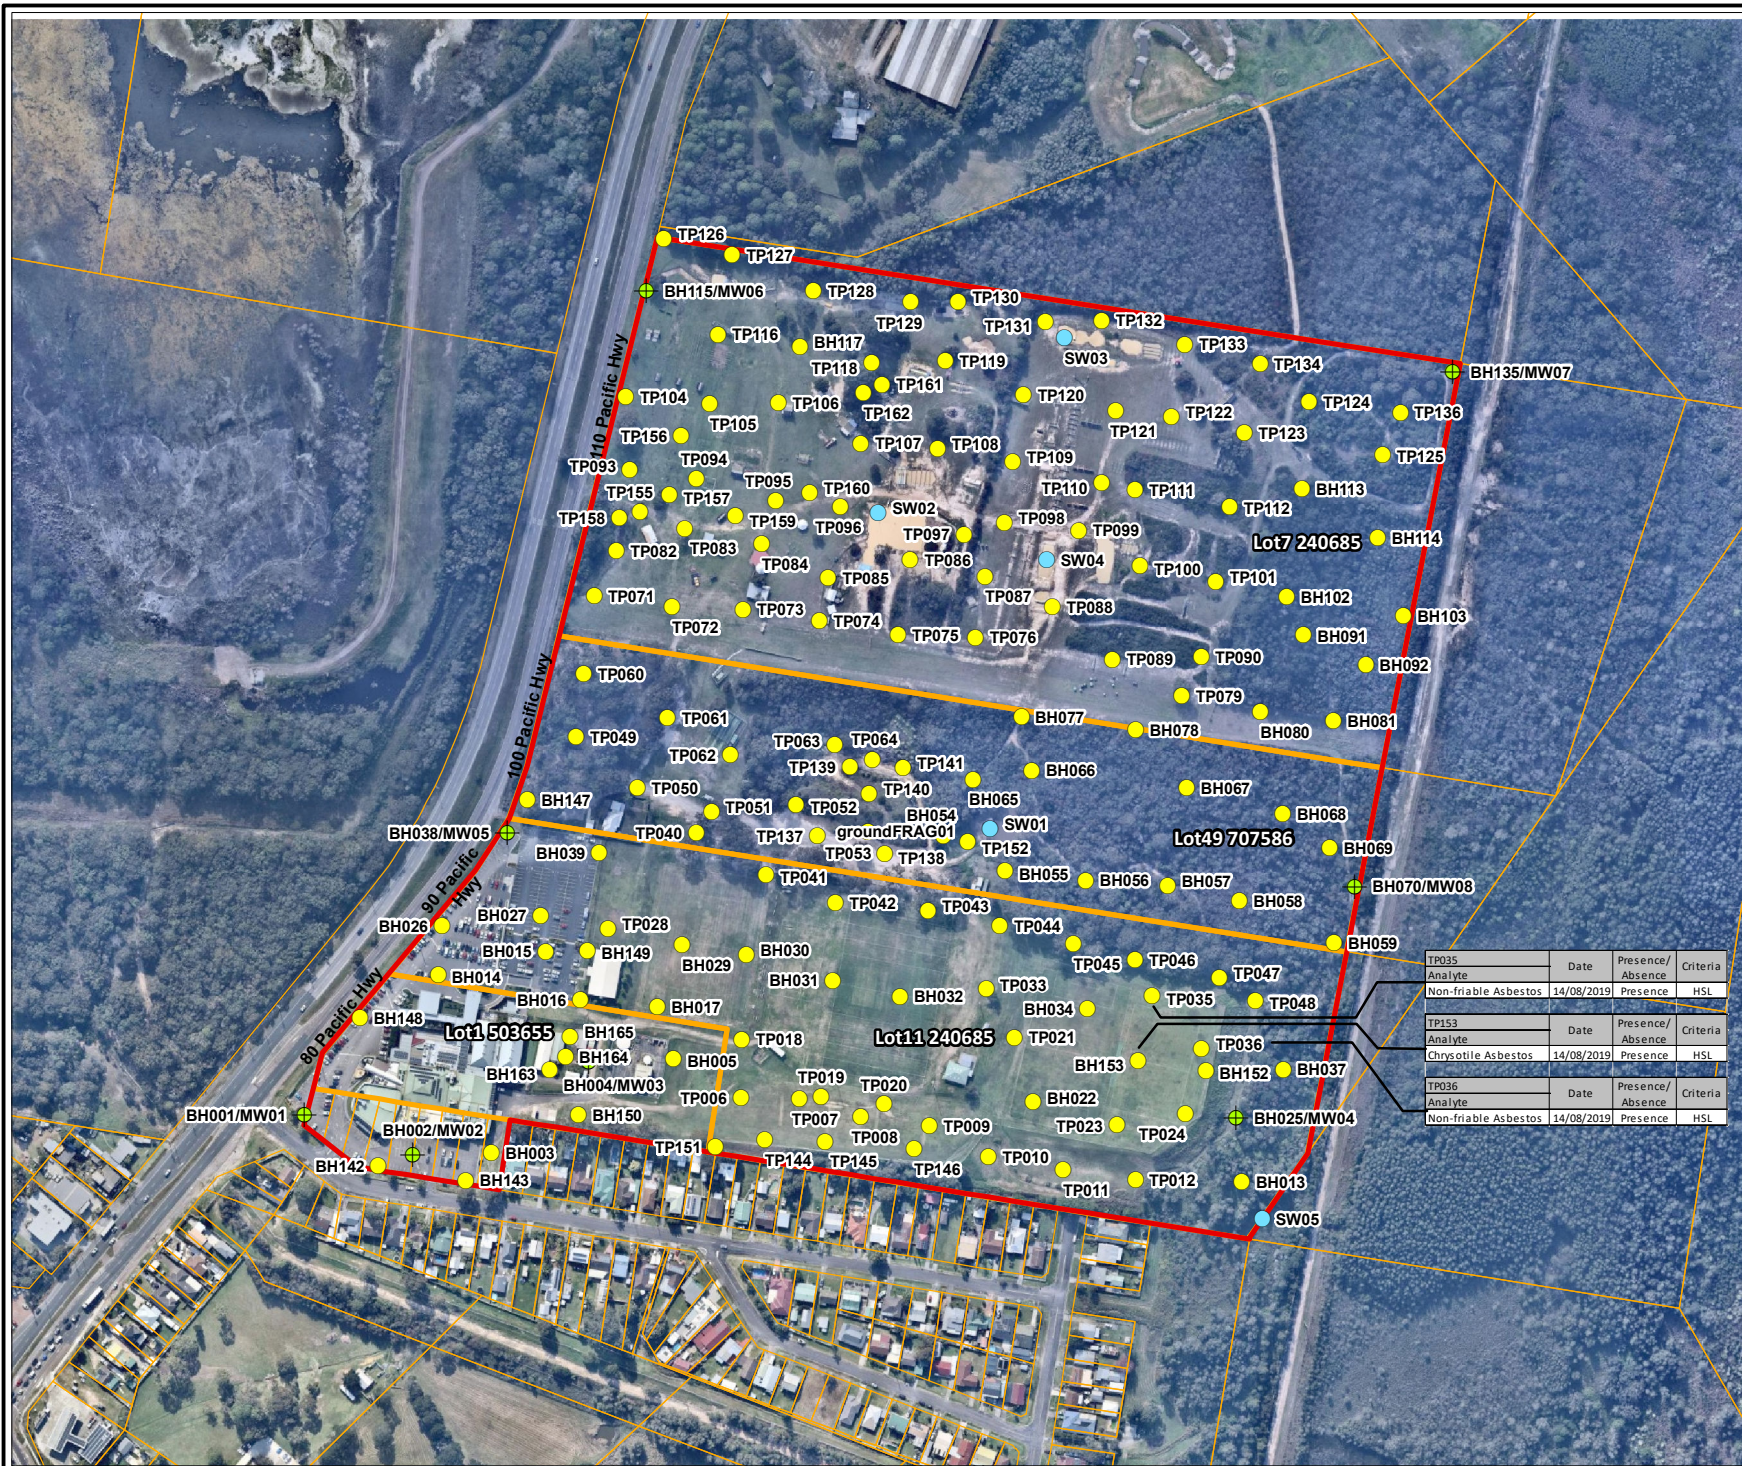
FIGURE 3

**HISTORICAL SAMPLE
LOCATIONS AND EXCEEDANCES**

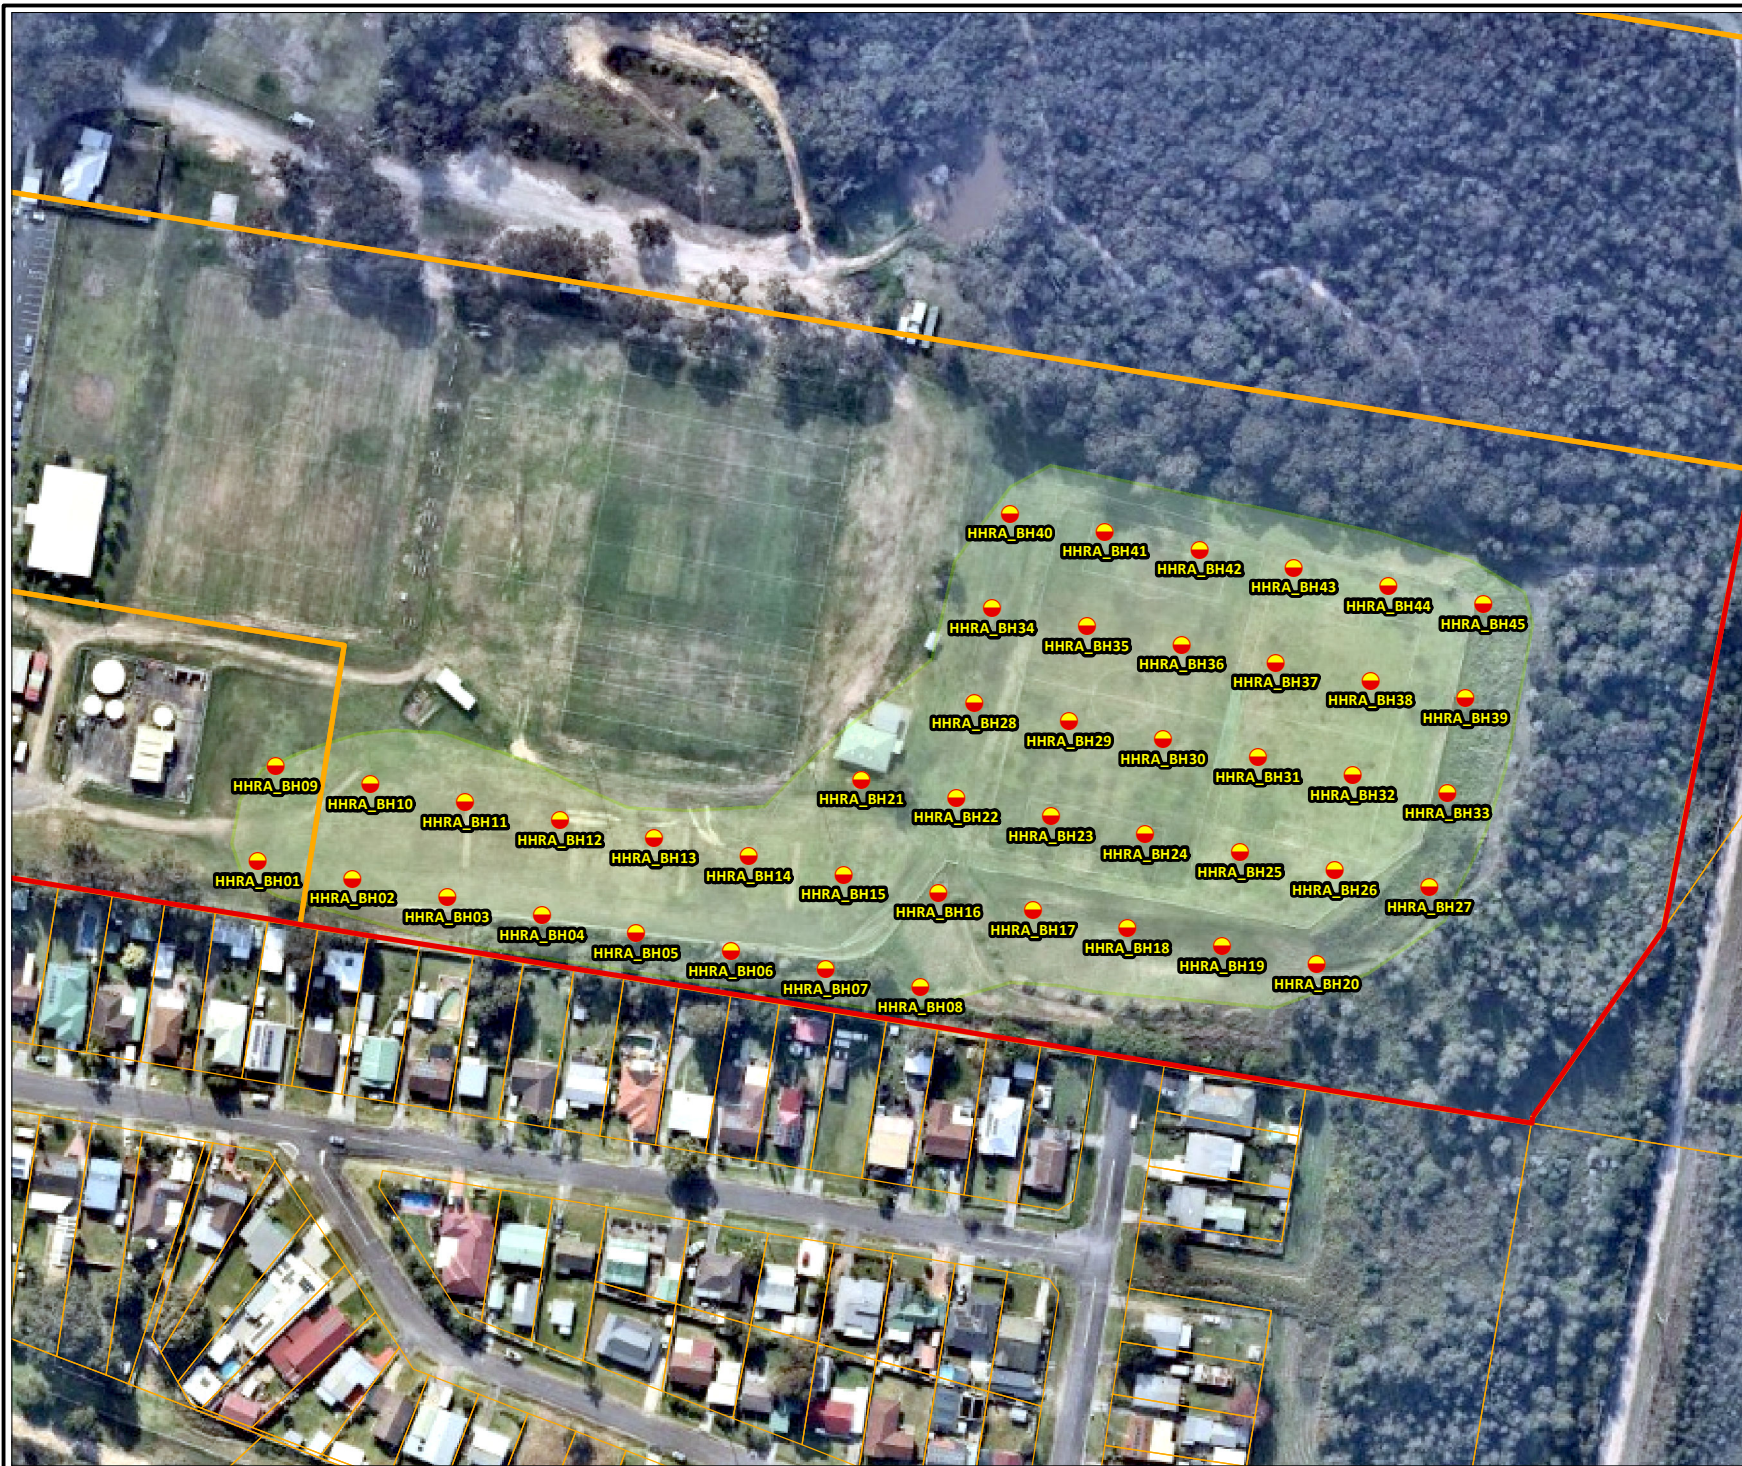
presence of ‘*uncontrolled fill material without mixed building waste*’ is identified, the likelihood of asbestos within shallow soils was considered to be ‘*possible*’. WA DOH (2009) recommends adopting a judgemental sampling approach or systematic sampling approach at half the EPA (1995) density. The adopted sampling density was 45 boreholes on a systematic grid basis over the management area (3.5 ha) as shown on **Figure 4**, noted to be greater than double the WA DOH (2009) recommendation.
