Remedial Action Plan
49-65 Wentworth Avenue and
80, 90, 100 and 110 Pacific Highway
Doyalson, NSW

3 October 2019

56387/124948(Rev B)
JBS&G Australia Pty Ltd

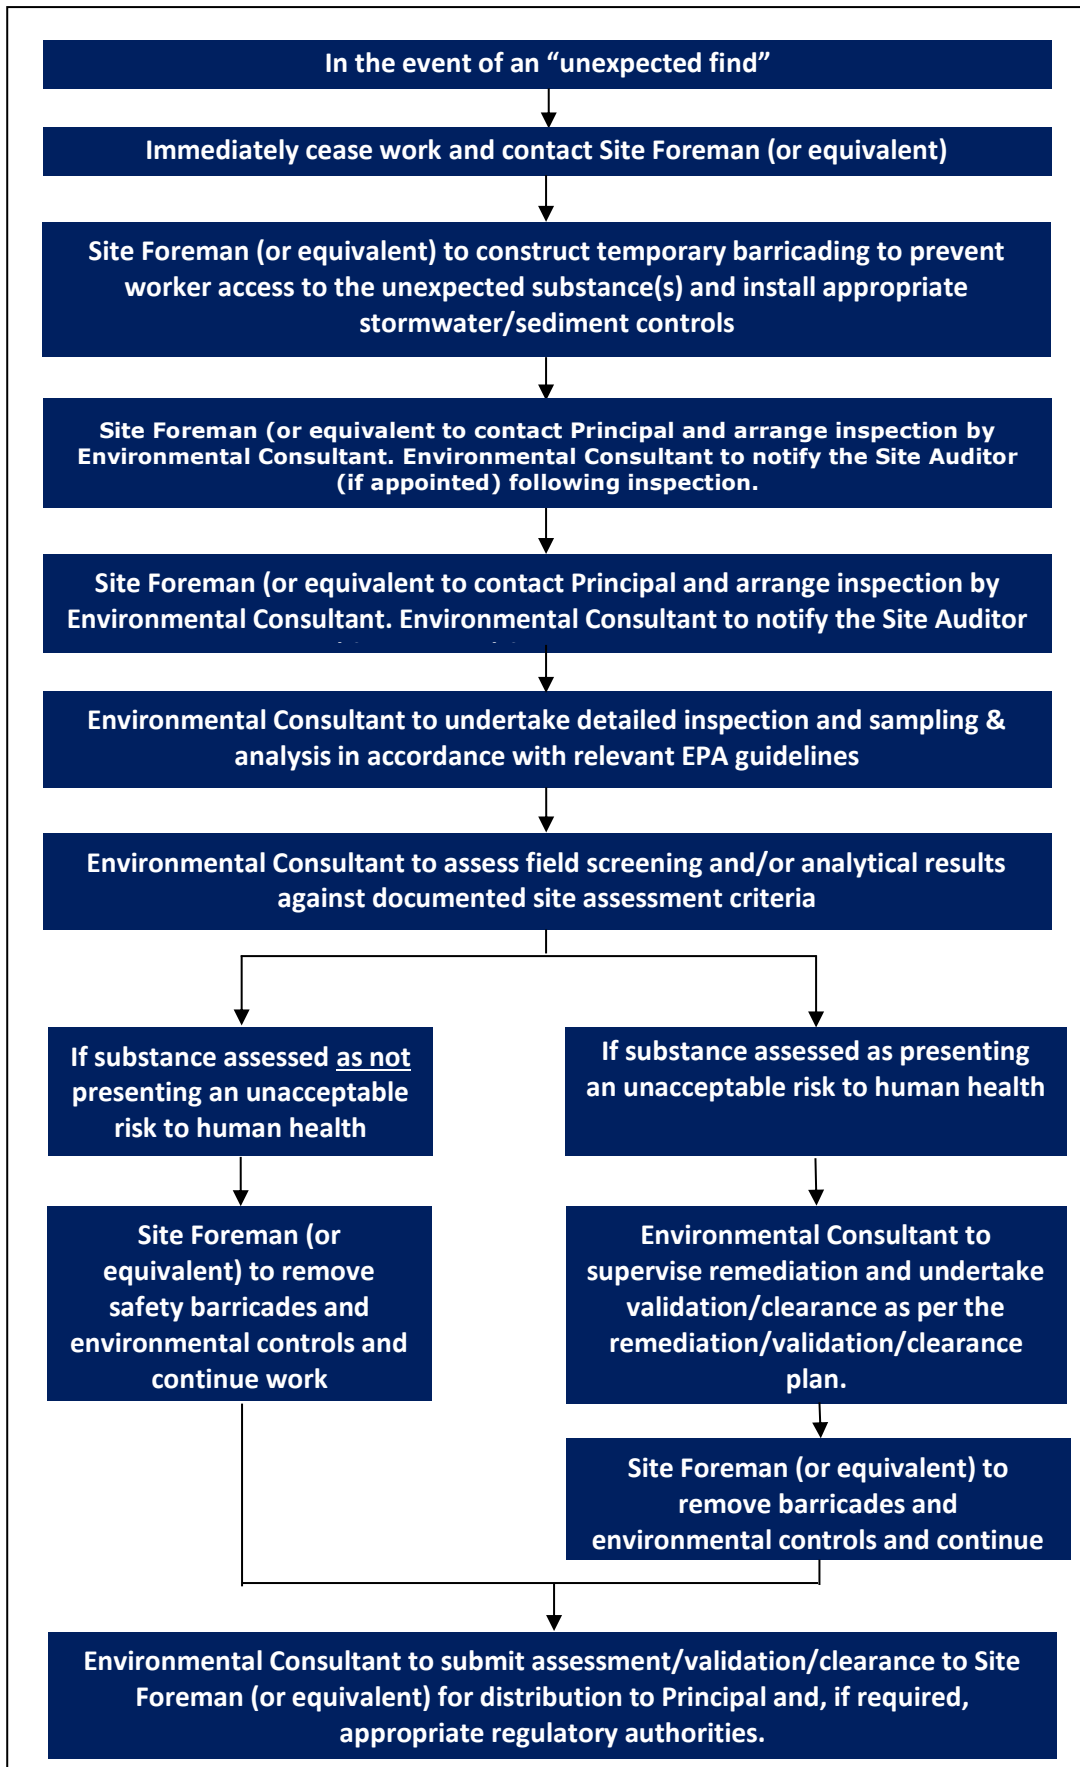
Flowchart 8.1 – Unexpected Finds Protocol

As a precautionary measure to ensure the protection of the workforce and surrounding community, should any of the abovementioned substances be identified (or any other unexpected potentially hazardous substance), the procedure summarised in **Flowchart 8.1** is to be followed.

The unexpected finds protocol should be presented and reviewed during the site-specific induction. Unexpected finds will require characterisation and resultant excavations will require validation according to **Table 9.3**.

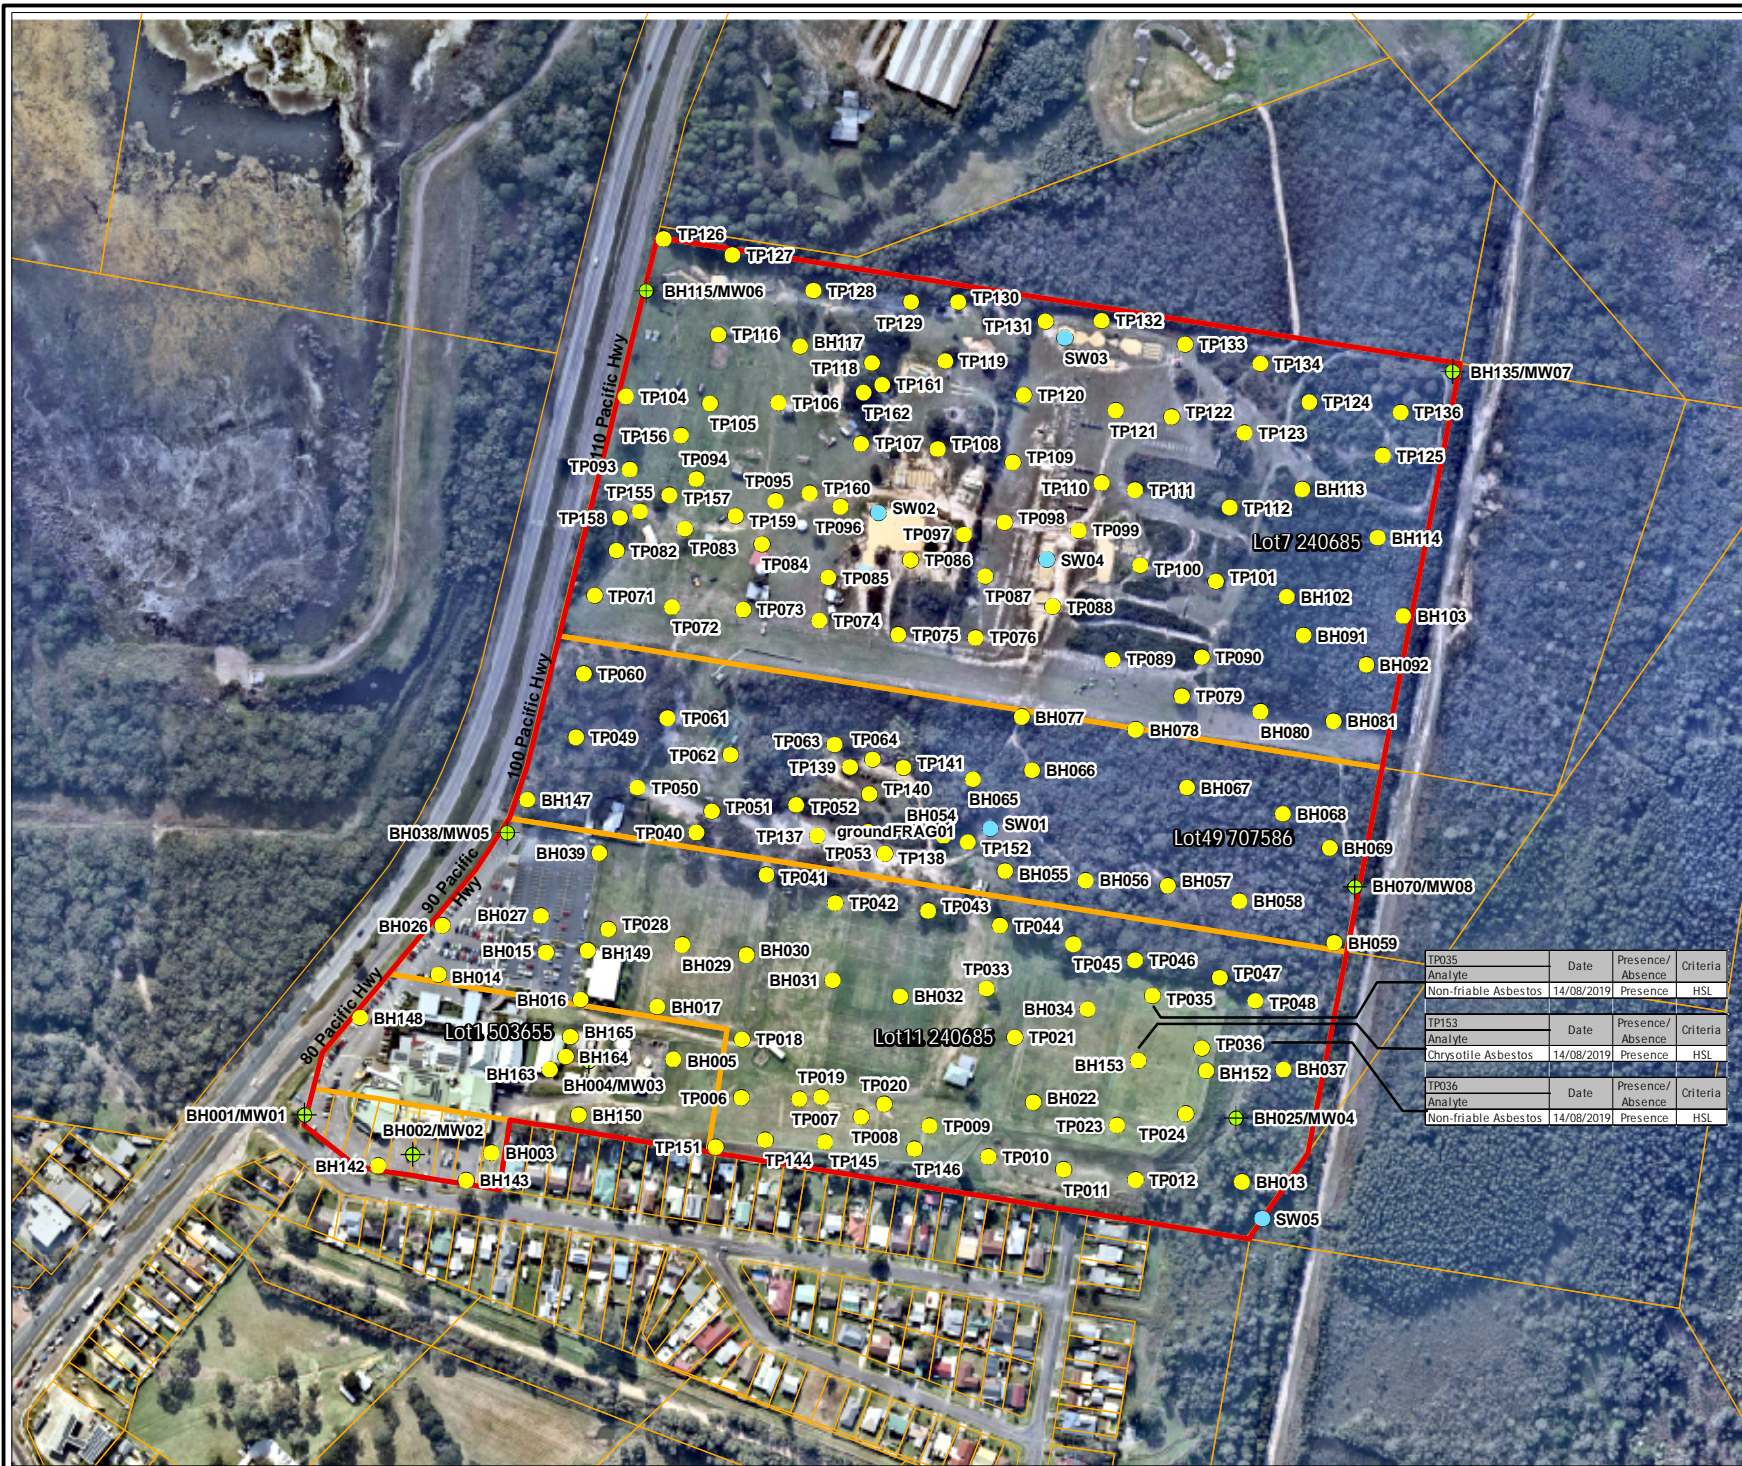
FIGURE 4

**HISTORICAL SAMPLE
LOCATIONS AND EXCEEDANCES**

- As noted in **Section 3.4**, no PFAS was reported in fill or natural material at the site. The PFAS occurrences in groundwater at MW01 and MW04 (**Figure 4**) were attributed to regional background levels, particularly as areas to the south and immediately east of site are designated PFAS investigation areas. For due diligence purposes, as part of this RAP, JBS&G propose to undertake supplemental PFAS characterisation of fill material and groundwater within the vicinity of the southern and eastern sports field (refer to **Section 4.3.1 and 4.3.2**).

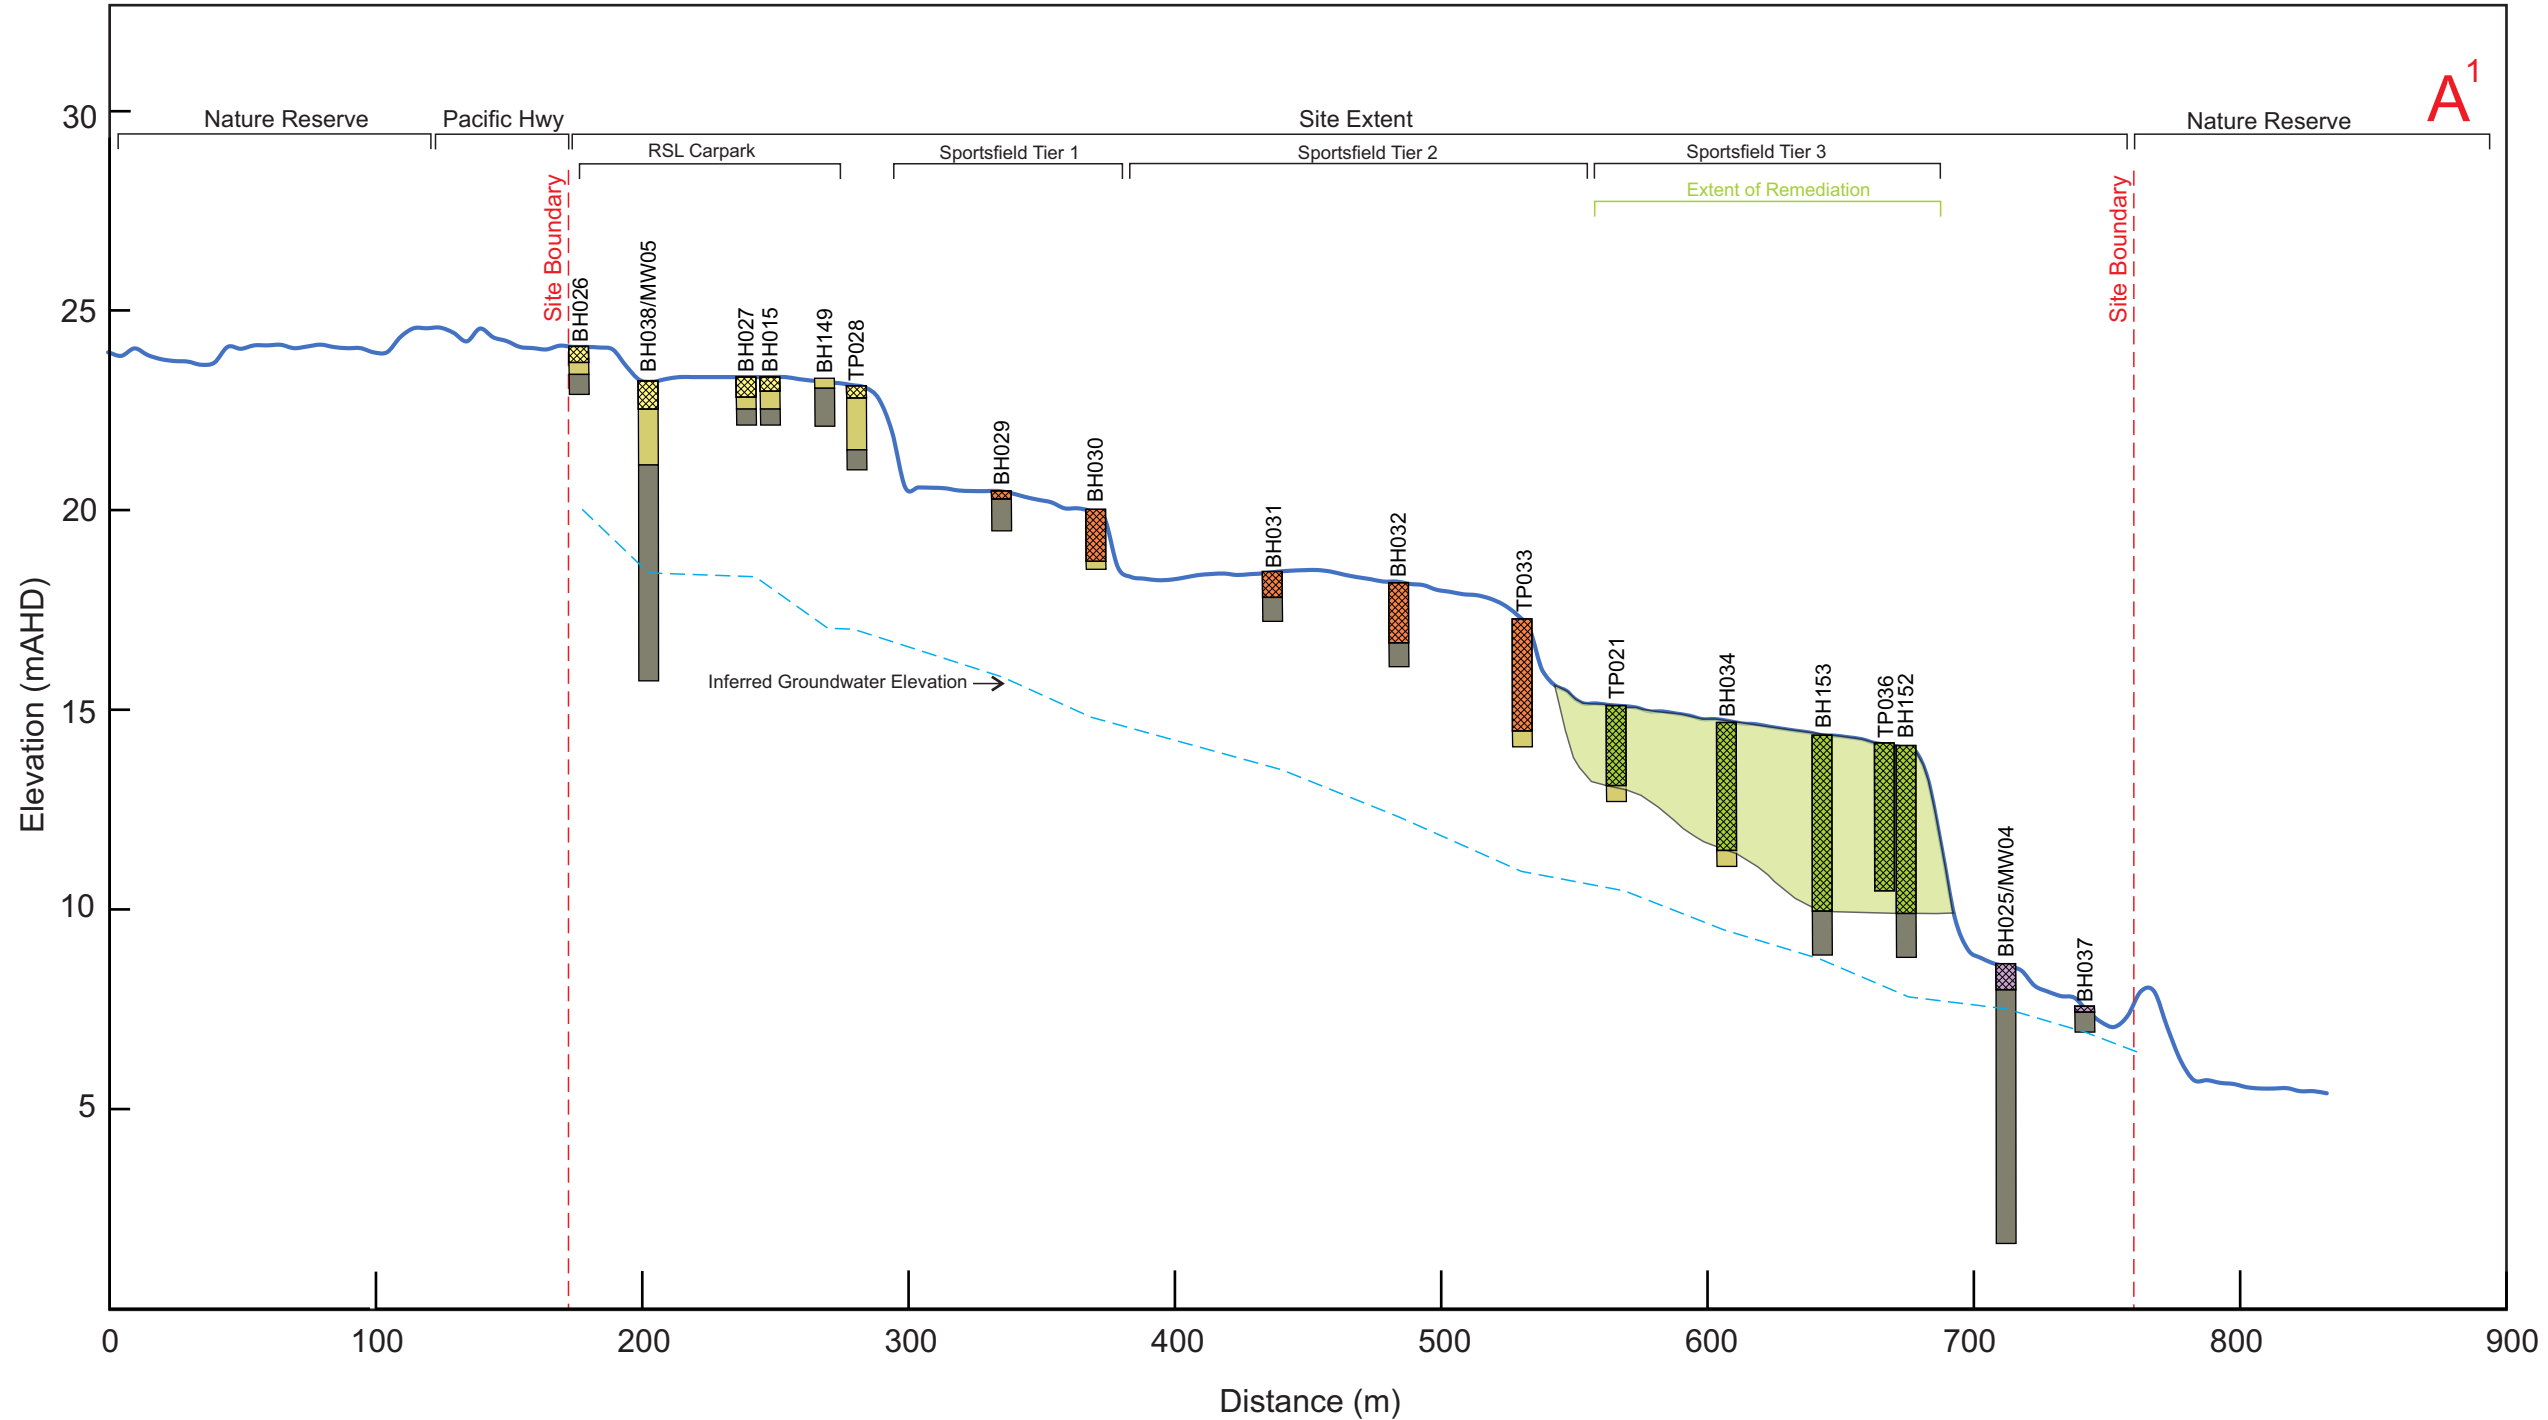
FIGURE 6:

- FILL - Orange Clayey SAND / Sandy CLAY (1976)
- FILL - Dark Grey / Brown Sandy CLAY / Sandy Gravelly CLAY (1994-2005)
- FILL - Other Silty SAND, Gravelly Silty SAND
- Natural SANDS
- Natural CLAYS
- Remediation Extent

CROSS SECTION

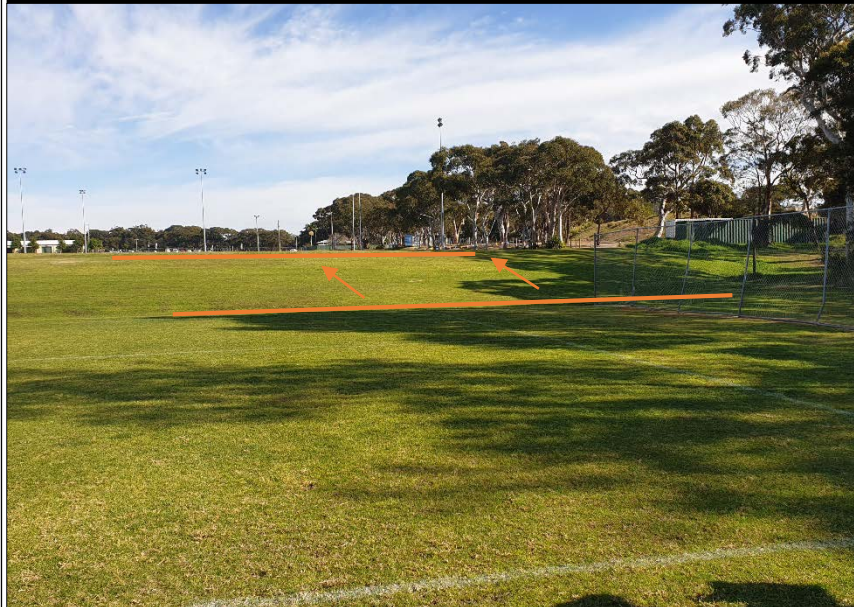
PHOTO 4: SHOWING THE EASTERN-MOST FIELD, FACING WEST, NOTE THE TERRACING BETWEEN FIELDS, 08/08/2019

With the exception of the sports fields (Lot 11), not significant fill was encountered. Cut and fill activities and suspected importation of fill had occurred within the sports fields areas in order to create the observed three tiers of levelled playing surfaces. It was observed that two distinct fill methods had been used; cut and fill of natural material in the two western sports fields and possible importation of fill in the south and eastern portion of the fields. In the eastern portion of the fields, the fill was observed to be approximately 4.4 m in depth (TP152 and TP153, **Appendix B**).

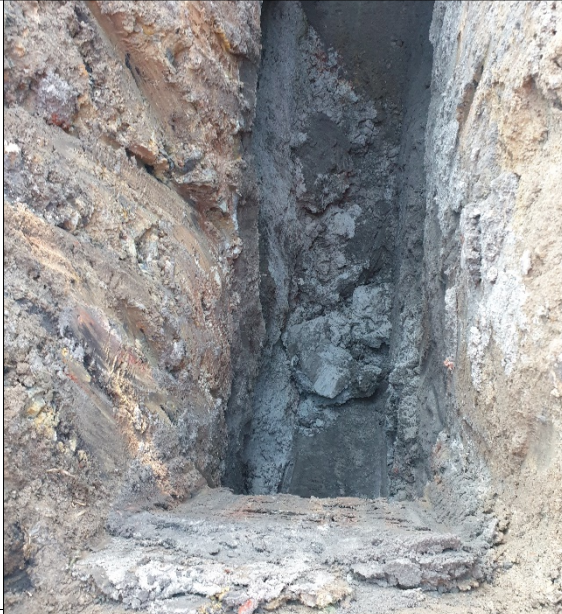
PHOTO 5: TP06 TEST PIT FILL. PHOTO TAKEN 13/08/2019

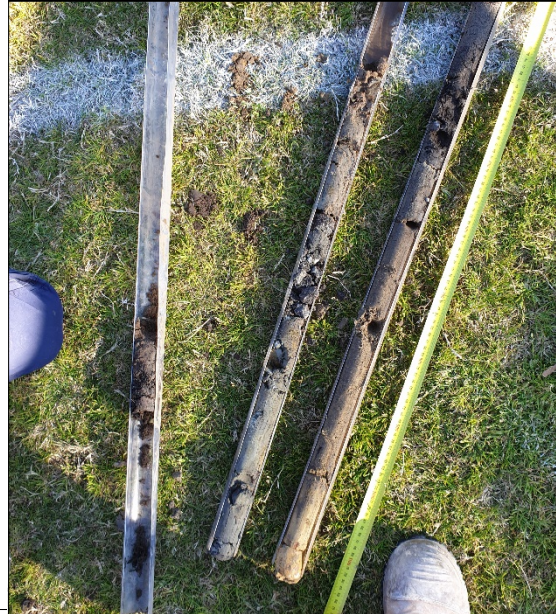
PHOTO 6: BH22. FILL PROFILE. 14/08/2019

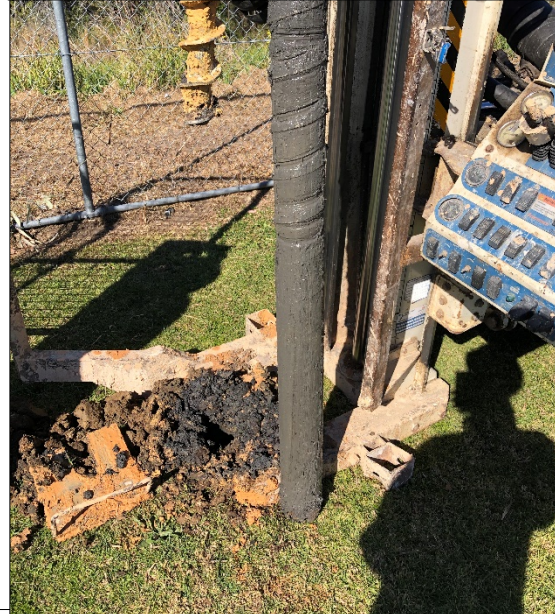
PHOTO 7: BH152. SATURATED DARK GREY FILL. 14/08/2019

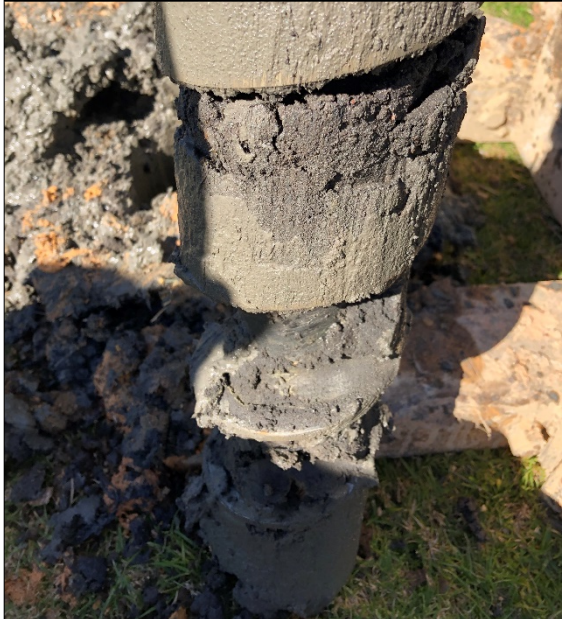
PHOTO 8: BH152. SATURATED DARK GREY FILL. 14/08/2019

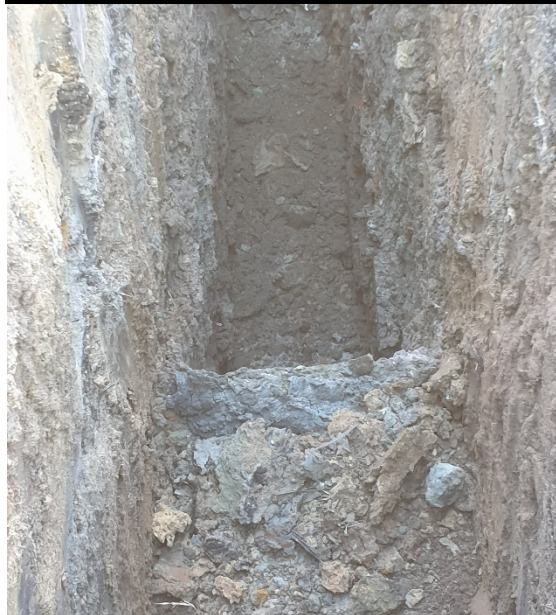
PHOTO 9: TP07 FILL PROFILE IN SOUTHERN PORTION OF SPORTS FIELDS. 13/08/2019

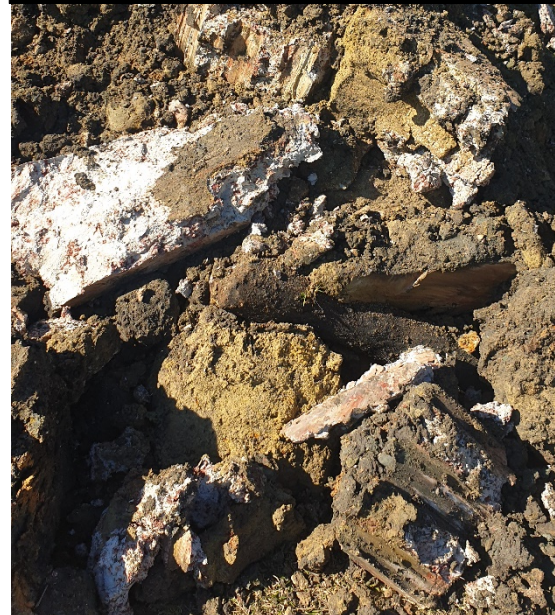
PHOTO 10: TP09 ANTHROPOGENIC INCLUSIONS IN FILL. 13/08/2019

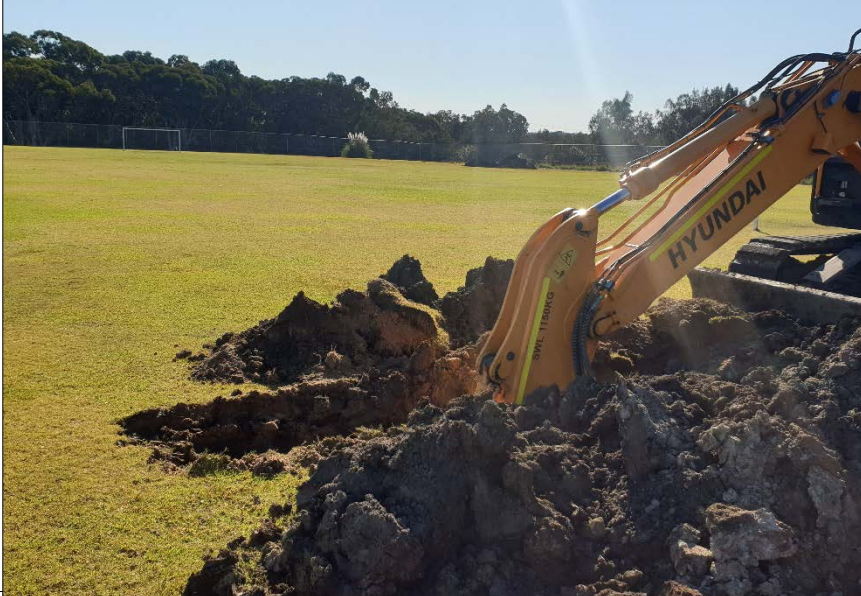
PHOTO 11: EXCAVATION OF TP23 IN AN AREA OF DEEP FILL IN THE EASTERN PORTION OF THE SPORTS FIELD, FACING NORTH-EAST, 14/08/19

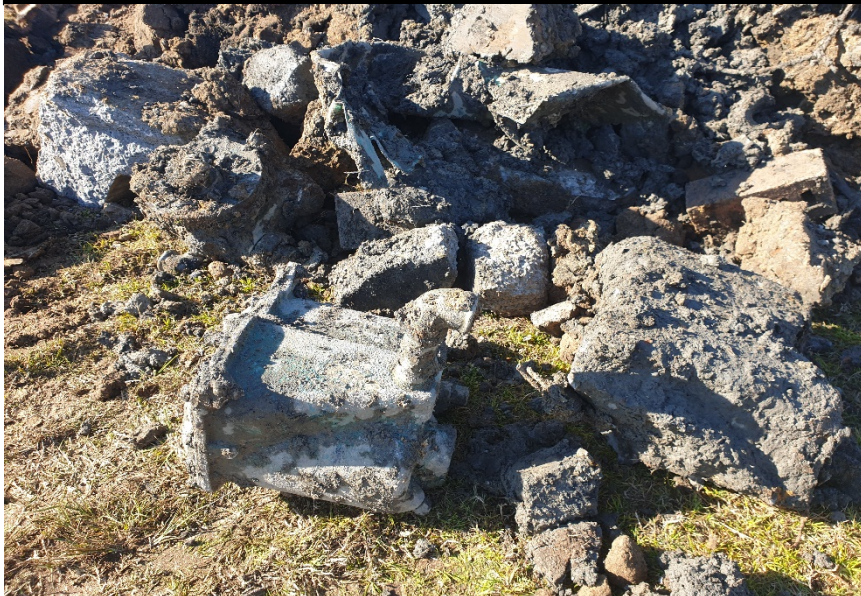
PHOTO 13: FILL FROM TP008 IN THE SOUTHERN PORTION OF SPORTS FIELD, WHICH INCLUDED A LARGE VOLUME OF DEMO WASTE AND ENGINE PARTS, 13/08/19

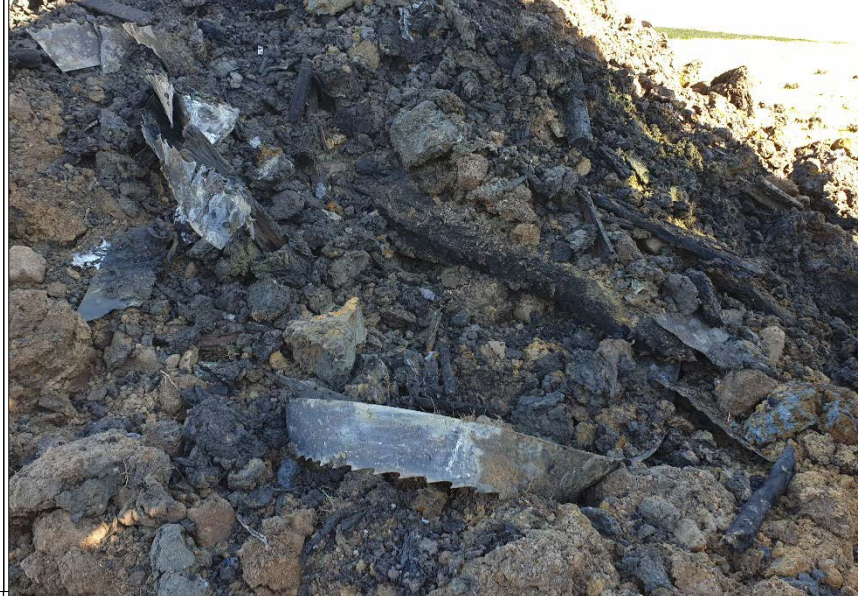
PHOTO 12: TP035 IN THE NORTHERN PORTION OF THE EASTERN SPORTS FIELD. FILL INCLUDED ACM, PLASTICS, SAW BLADES, ORGANICS AND BUILDING DEMO, 14/08/19

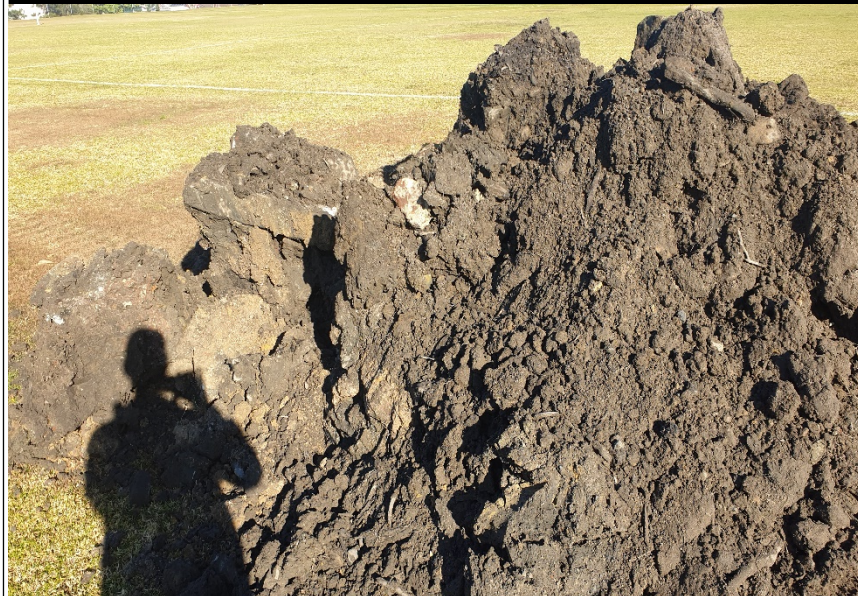
PHOTO 14: 90 PACIFIC HWY – TP36 THICK FILL FOUND TO BE TYPICAL OF THE EASTERN PORTION OF SPORTS FIELD, 13/08/19
